FBC DETAILED FLOOD MAPPING STUDY

Hummingbird Creek

FINAL
January 31, 2023

Prepared by BGC Engineering Inc. for:
Fraser Basin Council

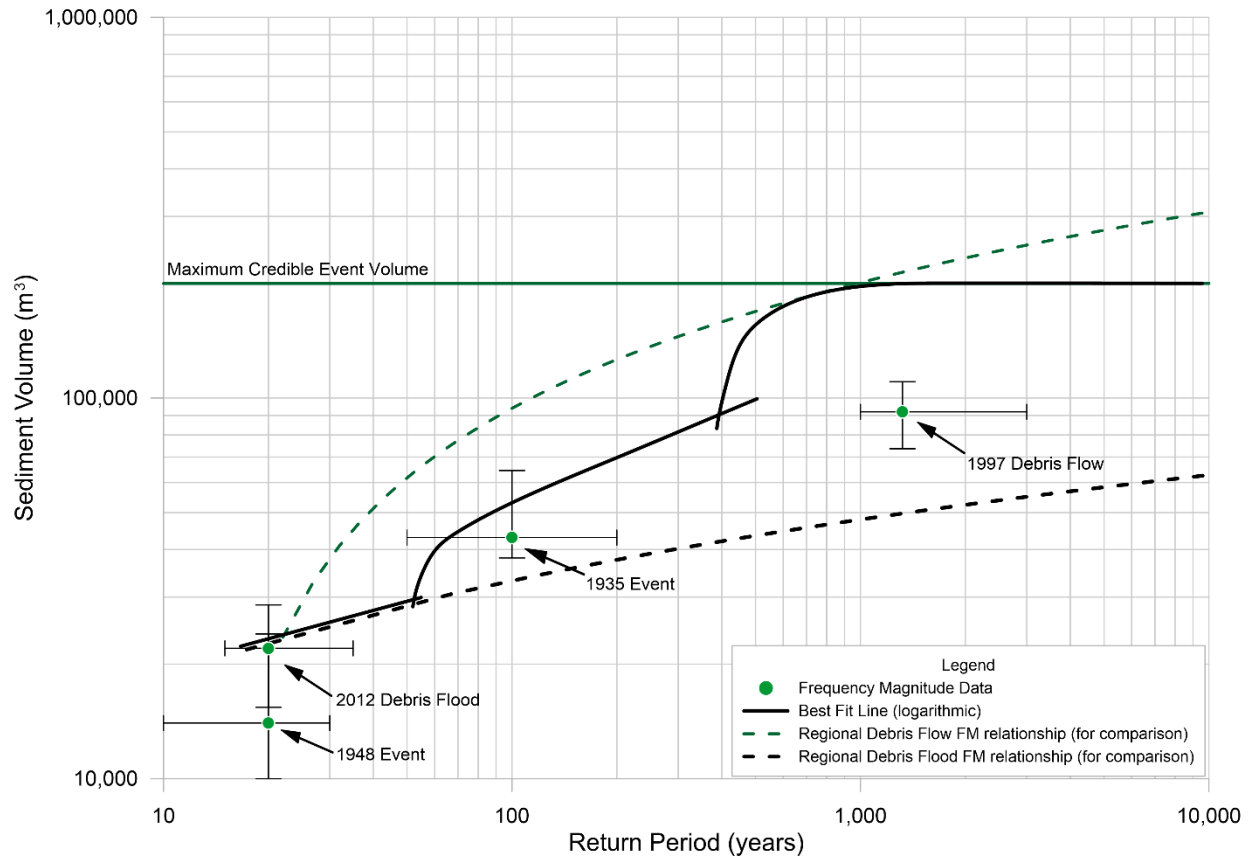
Figure E-1. The frequency-magnitude (F-M) model ensemble for Hummingbird Creek. The black solid curve shows F-M relationships for floods, debris floods and debris flows. The 1997 and 2012 events are shown for comparison, their respective frequencies are judgement-based.

Return Period (years)	Process	Debris Volume Best Estimate (m ³)	Peak Discharge (m ³ /s)
< 10	Flood	negligible	31
10 to 30	Type 1 debris flood	23,000	50
30 to 100	Debris flow	36,000	340
100 to 300	Debris flow	75,000	600
300 to 1000	Debris flow	170,000	1000
1000 to 3000	Debris flow	200,000	1200
>3000	Debris flow	200,000	1200

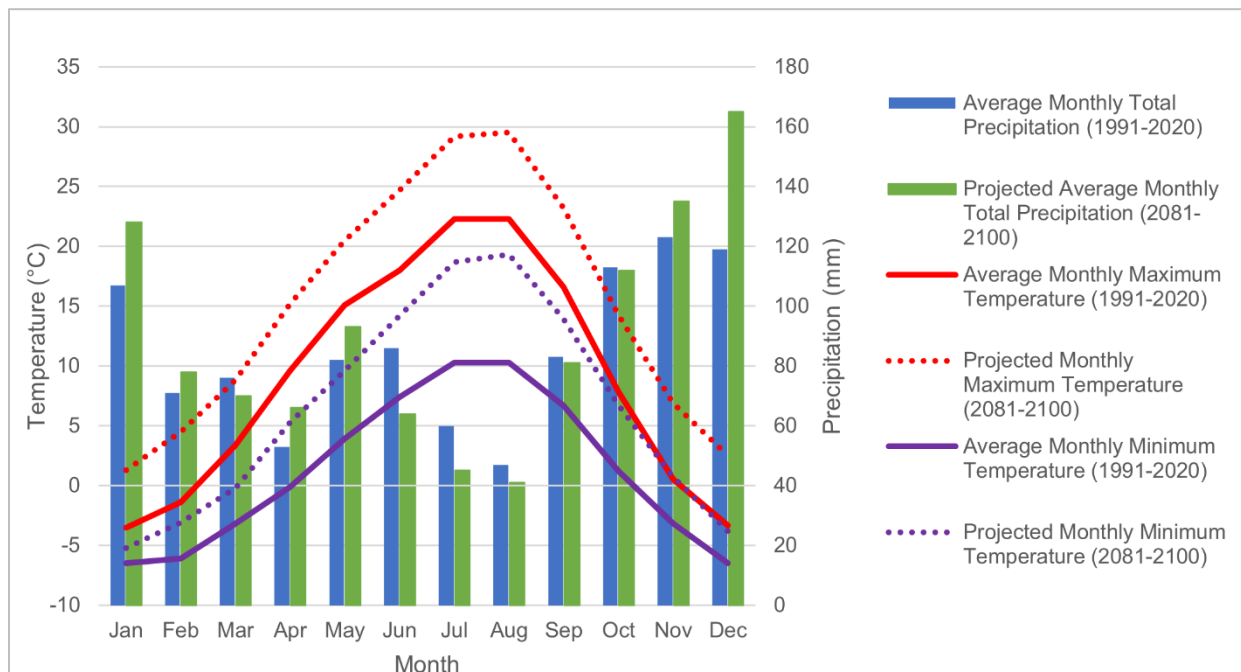
Figure 2-1. Historical and projected average monthly maximum and minimum temperature and average monthly total precipitation for the Hummingbird fan-delta. Source: Climate-BC.

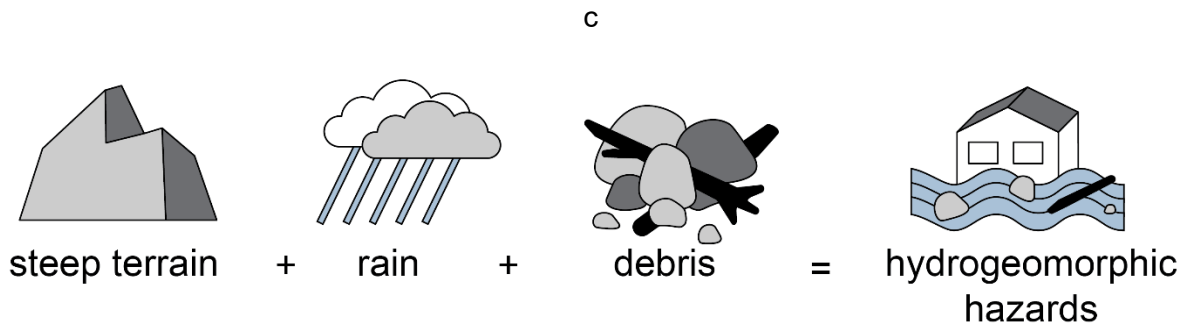
Figure 3-1. Illustration of steep creek hazards.

Steep creek or hydrogeomorphic hazards are natural hazards that involve a mixture of water and debris or sediment (Figure 3-1). These hazards typically occur on creeks and steep rivers with small watersheds (usually less than 100 km²) in mountainous terrain, usually after intense or long rainfall events, sometimes aided by snowmelt and worsened by forest fires.

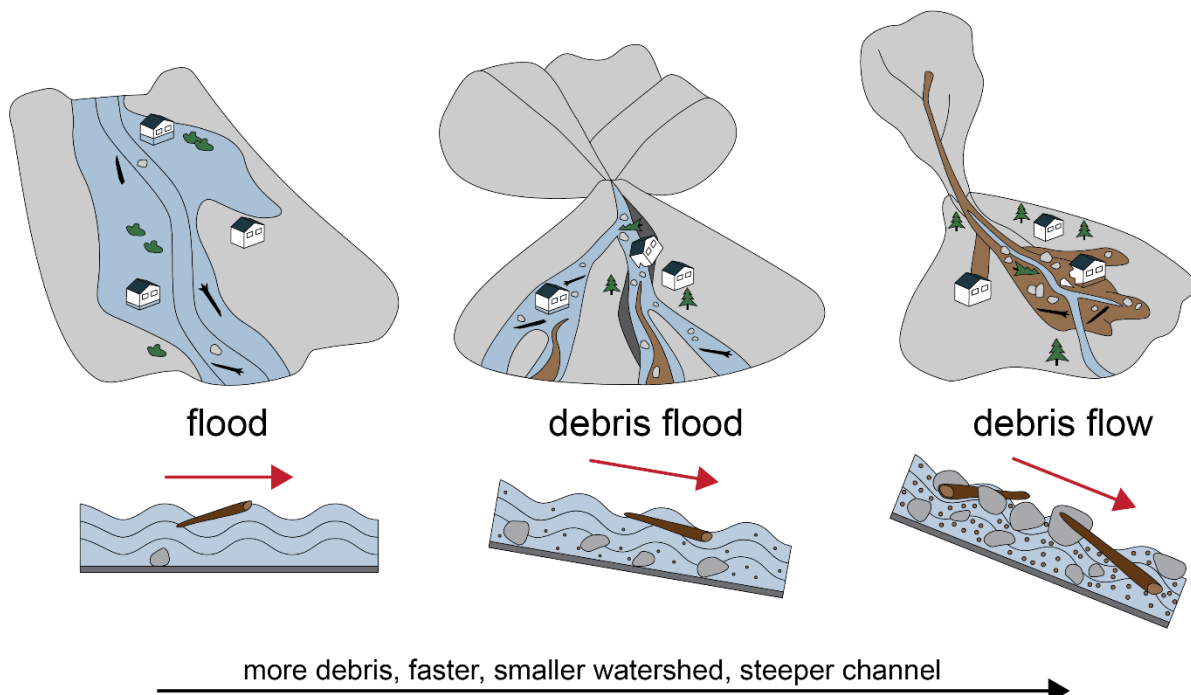
Figure 3-2. Continuum of steep creek hazards.

Steep creek hazards span a continuum of processes from clearwater floods (flood) to debris flows (Figure 3-2). The following two sections describe some general characteristics of debris floods and debris flows and how they differ from floods.

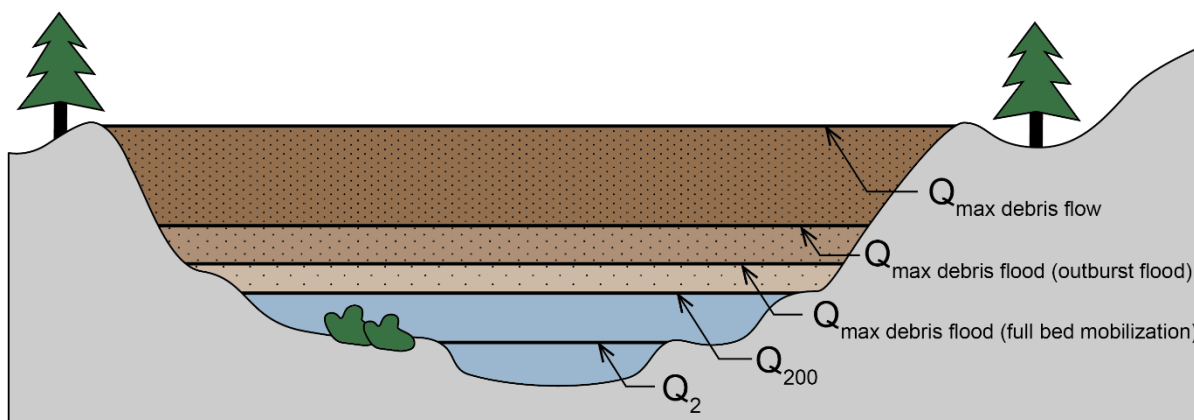
Figure 3-3. Conceptual steep creek channel cross-section showing peak discharge levels for different events. Note that for some outburst floods or debris flows the discharge may exceed what is shown here.

- Q_2 ; Clearwater flow with 2-year return period
- Q_{200} ; Clearwater flow with 200-year return period (i.e., a clearwater flood)
- $Q_{\text{max debris flood (full bed mobilization)}}$; Type 1 debris flood generated by full bed mobilization
- $Q_{\text{max debris flood (outburst flood)}}$; Type 3 debris flood generated by an outburst flood
- $Q_{\text{max debris flow}}$; Debris flow.

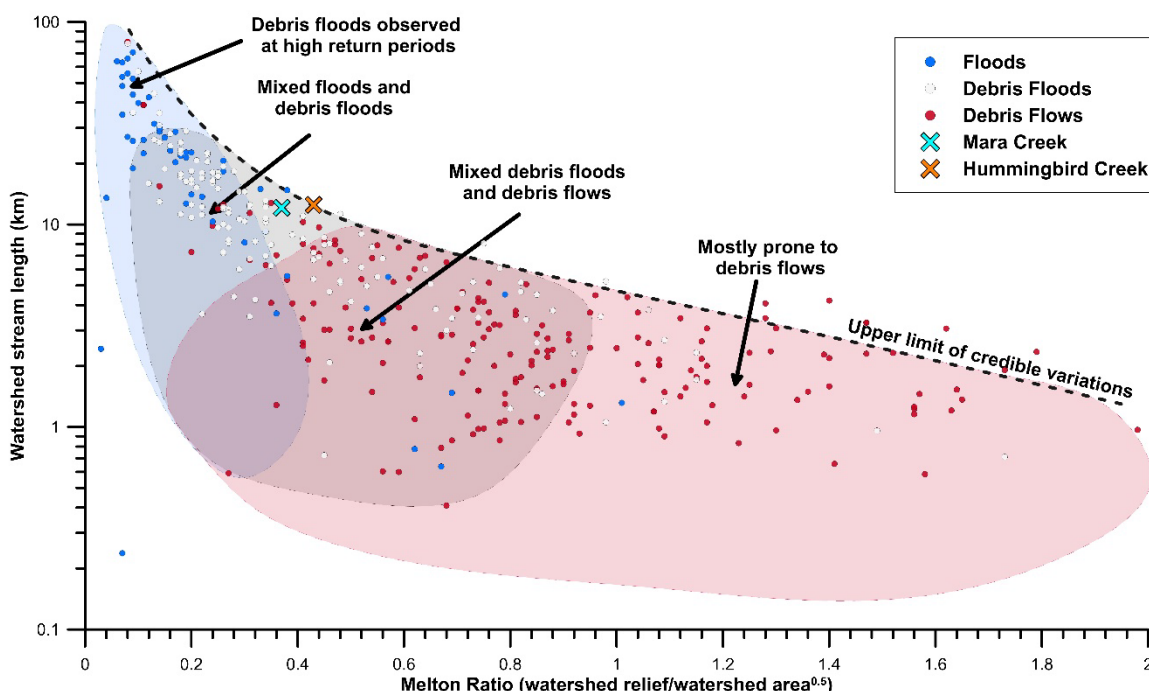
Figure 4-2. Steep creek classification into floods, debris floods and debris flows from field observations across Alberta and British Columbia compiled by BGC. Melton ratio is the ratio of elevation range to the square root of watershed area and an indicator of the relative susceptibility of a watershed to debris flows, debris floods or floods.

- Empirical analyses (Figure 4-2) suggest that both debris floods and debris flows are possible on Hummingbird Creek and Mara Creek watersheds.
- The creek produced a debris flow on July 11, 1997, and a debris flood on June 23, 2012. These events are further discussed in Section 4.2.
- BGC observed evidence of past debris floods in the upper watersheds of both Mara and Hummingbird Creeks (Photos 10 and 11).

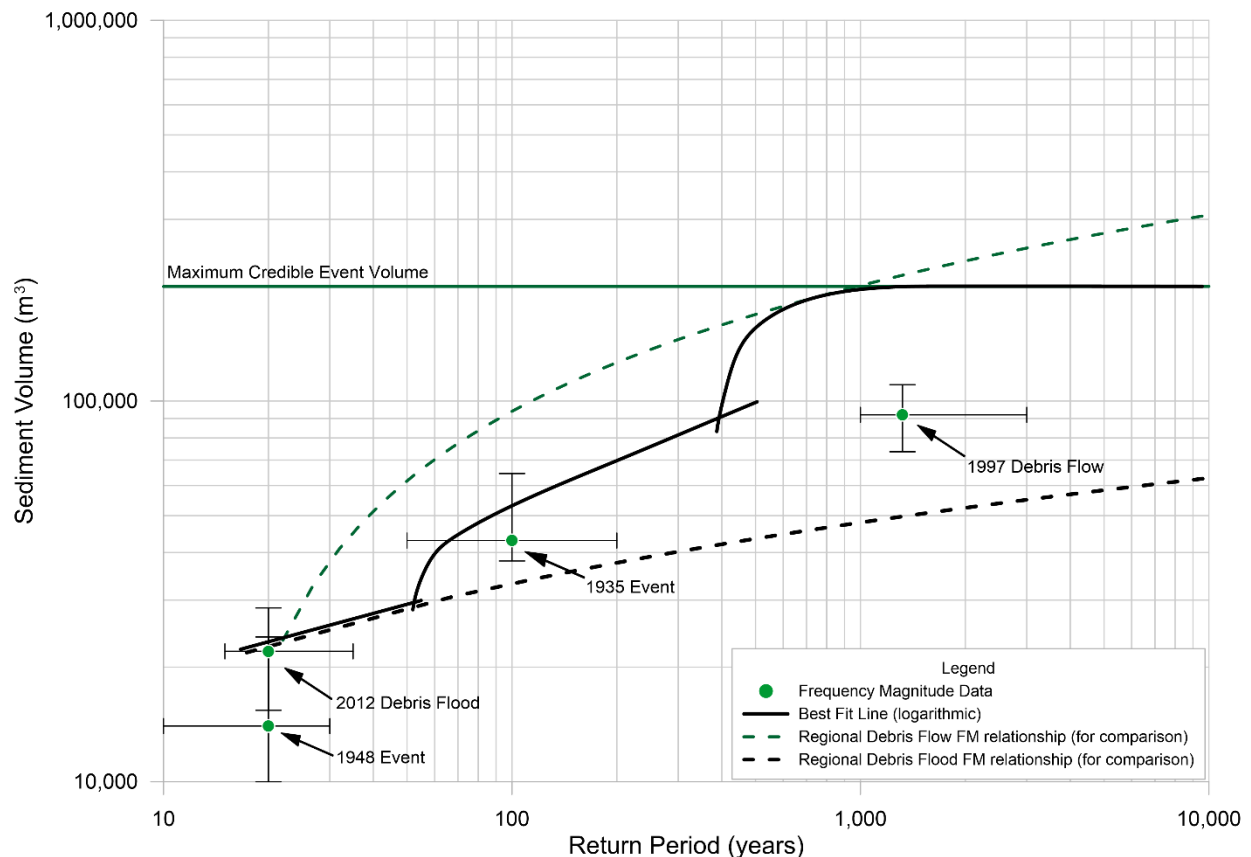
Figure 4-3. The frequency-magnitude (F-M) model ensemble for Hummingbird Creek. The black solid curve shows F-M relationships for floods, debris floods and debris flows. The 1997 and 2012 events are shown for comparison. Error bars are based on judgement.

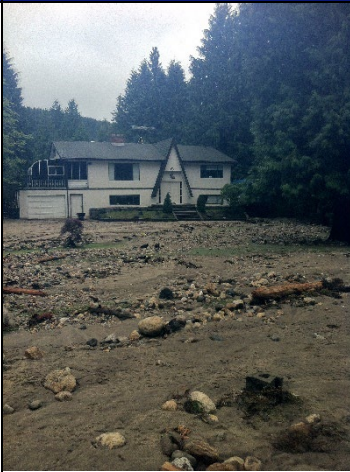
<p>Sedimentation and damages on the lower fan-delta of Hummingbird Creek following a debris flood in June of 2012. Photo courtesy of CSRD June 2012.</p>
1 to 10	Orange	Moderate	Mostly slow but potentially fast flowing shallow or deep flow with some debris. High likelihood of sedimentation and water damage. Potentially dangerous to people in the basement or first floor of buildings without elevated concrete foundations.

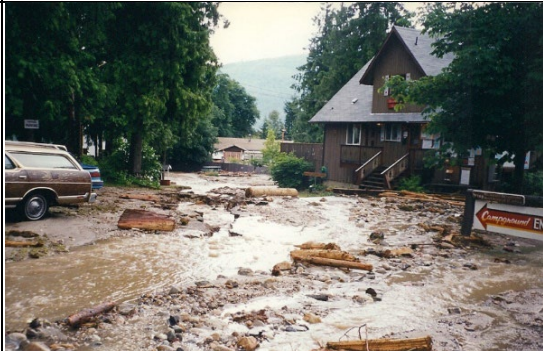
<p>Looking west on the lower fan-delta of Hummingbird Creek following the debris flow on July 11, 1997. Photo courtesy of Sicamous Museum July 1997.</p>
10 to 100	Pale Red	High	Fast moving and deep water carrying debris and/or large boulders. High likelihood of major structural damage and severe sedimentation and water damage. Very dangerous to people.

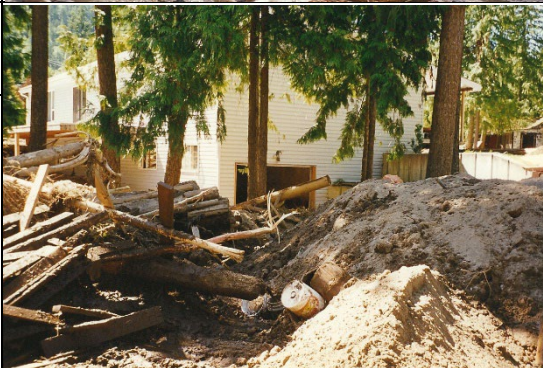
<p>Looking at damages to an unknown building on the fan-delta of Hummingbird Creek following the debris flow on July 11, 1997. Photo courtesy of Sicamous Museum July 1997.</p>

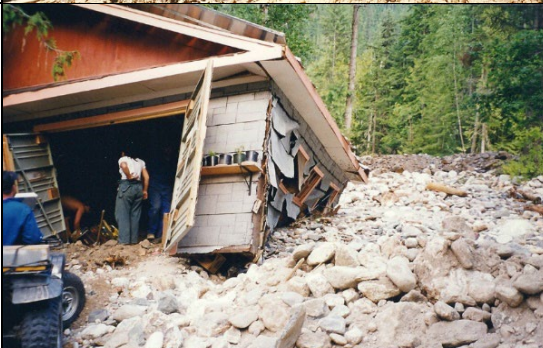
100 to 1000	Red	Severe	Very fast moving and deep water carrying debris and large boulders. High likelihood of total building destruction and very high likelihood of major structural damage. Extremely dangerous to people.	
> 1000	Brown	Complete Destruction	Very fast moving and deep water carrying significant amounts of debris and large boulders. Very high likelihood for total building destruction. Extremely dangerous to people.

<p>Looking at damages to an unknown building on the upper fan-delta of Hummingbird Creek following the debris flow on July 11, 1997. Photo courtesy of Sicamous Museum July 1997.</p>

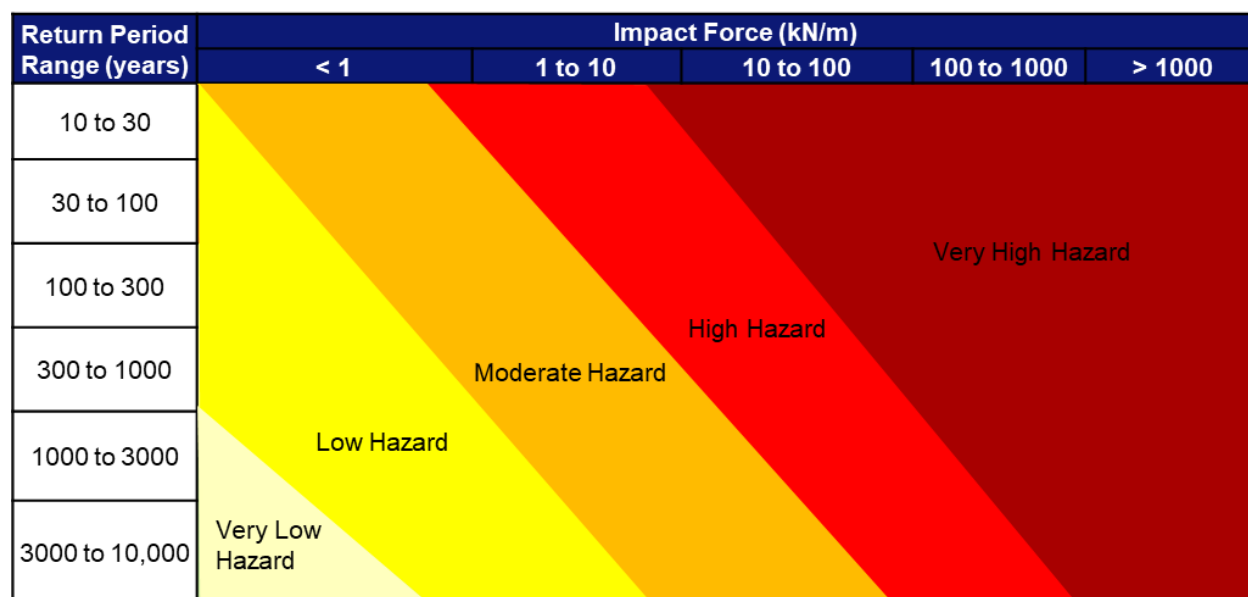
Figure 5-1. Matrix illustrating the colour scheme and final hazard rating provided in the composite hazard map. The composite hazard map combines the modelled impact force from each hazard scenario and the annual probability of occurrence of the hazard.

The composite hazard map incorporates the ensemble of modelled hazard scenarios into a single map. It represents the current hazard on the fan-delta by combining the modelled impact forces from all hazard scenarios and the annual probability of occurrence for each hazard (i.e., debris flood or debris flow). The highest return bank erosion corridor modelled is also provided in the composite hazard map and is colour coded according to Figure 5-1 assuming bank erosion damage is approximately equivalent to an impact force of 1 to 10 kN/m. Figure 5-1 illustrates how the colour scheme and final hazard rating provided in the composite hazard map are estimated based on the probability of occurrence of difference classes of impact forces (examples of impact force potential damage provided in Table 5-1).

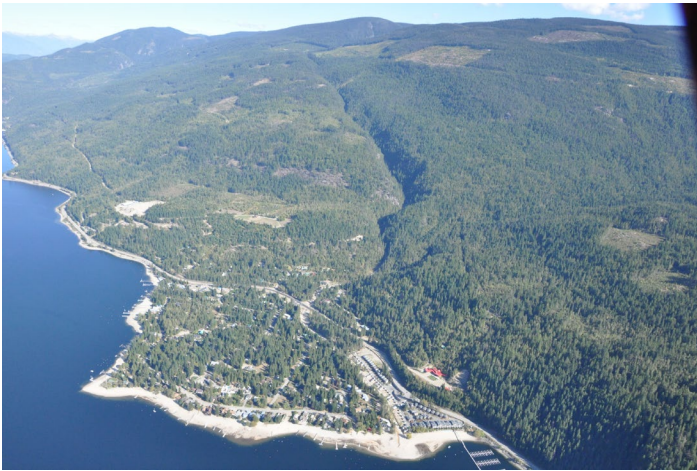
Photo 1.

Looking northeast at Hummingbird Creek fan-delta and upslope watershed. Note the relatively flat plateau in the upper watershed and the steep channel flowing down to the fan-delta.

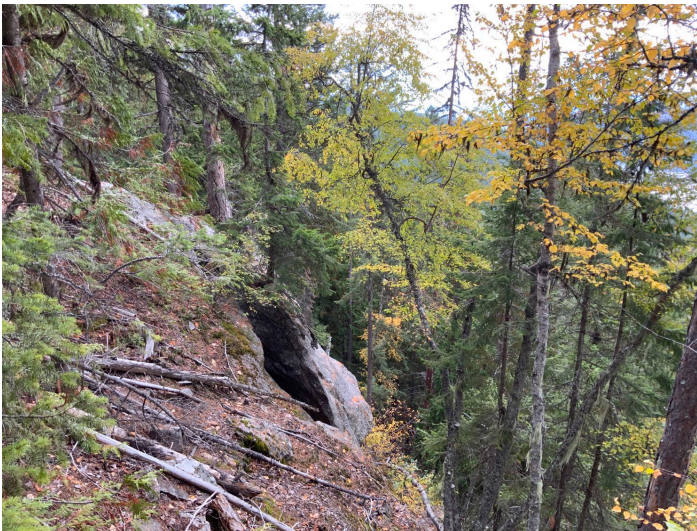
Photo 2.

Looking south at steep bedrock cliffs interpreted to be large landslide headscarps in Mara Creek approximately 1.8 km southeast of the fan-delta apex (see location in Drawing 05).

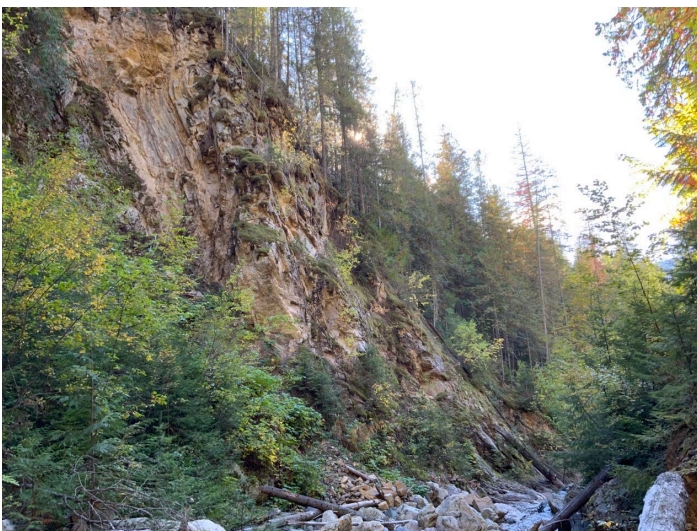
Photo 3.

Looking west (downstream) at steep bedrock slopes adjacent to Hummingbird Creek approximately 150 m upstream of the fan-delta apex. The steep slopes are subject to rockfalls (see location in Drawing 05).

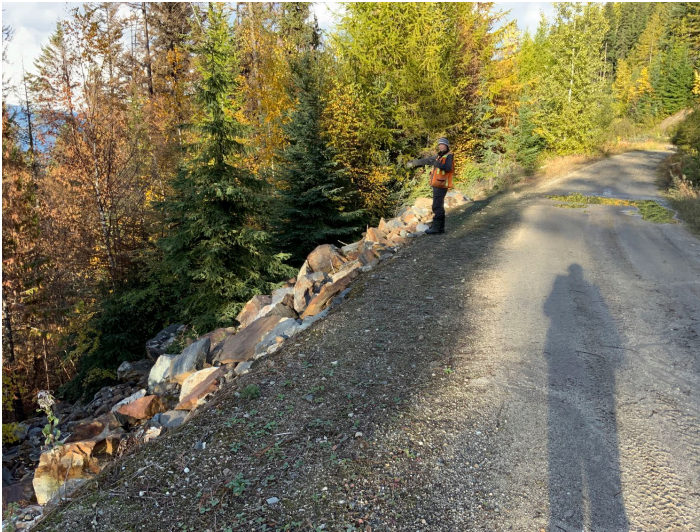
Photo 4.

Looking north at the source of the 1997 debris flow below the Skyline forestry road in the Hummingbird Creek watershed (see location in Drawing 05). Note the rip rap placed on the slope below the forestry road.

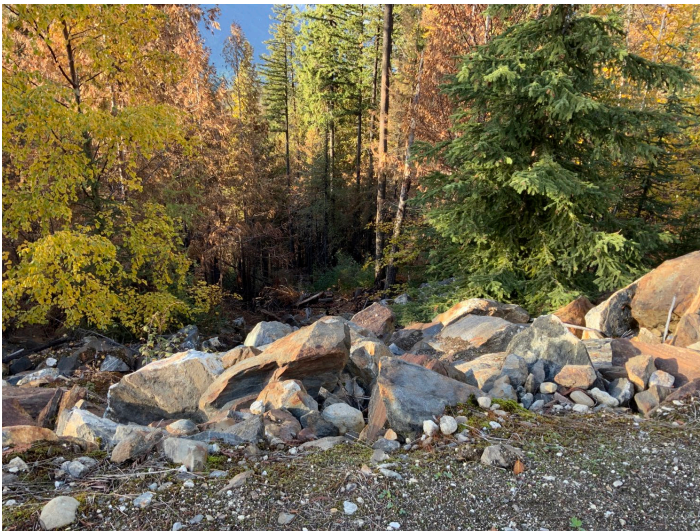
Photo 5.

Looking northeast at the source of the 1997 debris flow below the Skyline forestry road in the Hummingbird Creek watershed (see location in Drawing 05). Note the rip rap placed on the slope below the forestry road and the moderately burnt trees on either side of the debris slide path.

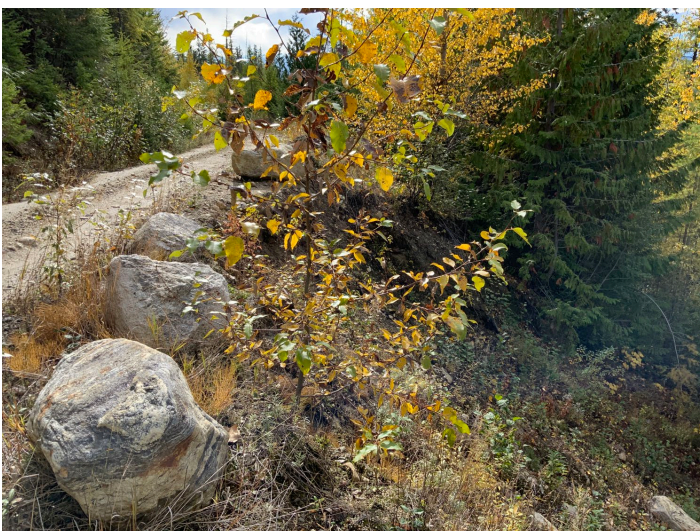
Photo 6.

Looking south at a debris slide triggered by forestry road failure in the Mara Creek watershed (see location in Drawing 05). The large boulders on the left photo demark the top of the debris slide.

- The re-occurrence of a debris flow originating downslope of a forest road may be reduced due to changes to forestry road management made after the 1997 debris flow (Forestry Practices Board, August 2001) but is still possible (Photo 6, Drawing 05). Therefore, BGC included the potential for logging road related debris flows in the estimate of debris flow return periods.

(Forest Practices Board, August 2001). However, BGC still observed recent debris slides originating below forestry roads (Photo 6, Drawing 05). Therefore, BGC included the potential for logging road related debris flows in the estimate of debris-flow return periods.

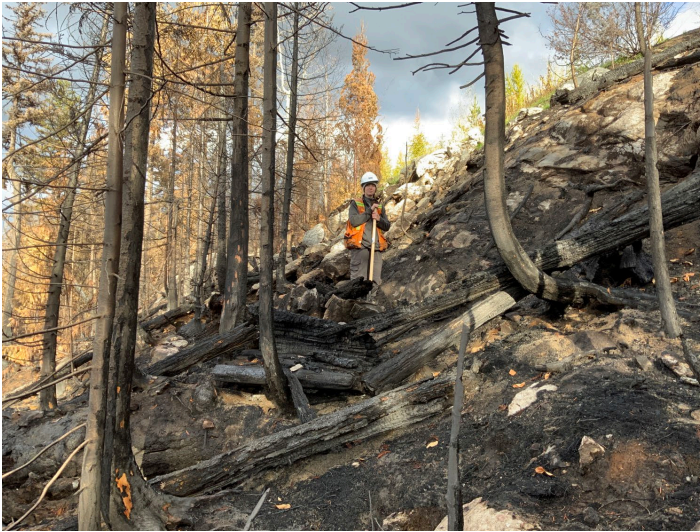
Photo 7.
Looking north at moderately burnt vegetation on bedrock-controlled slopes of Hummingbird Creek. The burn is approximately 10 m downslope of the forestry road.

Vegetation in the watershed is comprised of alpine fir, red cedar, western Hemlock, western larch, spruce, interior Douglas Fir, lodgepole pine, Wet Interior Cedar-Hemlock and Engelmann-Spruce forests (Government of British Columbia, 2021). Approximately 1 km² (3%) of the watershed burned in 2021 from the Two-Mile Road Fire (K42078). Drawing 04 shows the extent of the 2021 burn perimeter. Most of the burn occurred in the mid to upper reaches of Hummingbird Creek. Photo 7 shows an example of a burnt slope in the Hummingbird Creek watershed.

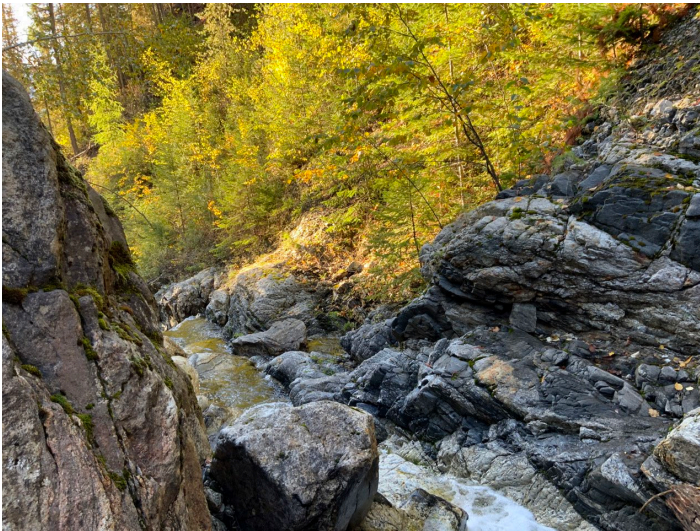
Photo 8.
Looking west (downstream) at bedrock-controlled channel of Hummingbird Creek approximately 400 m upstream of the fan-delta apex.

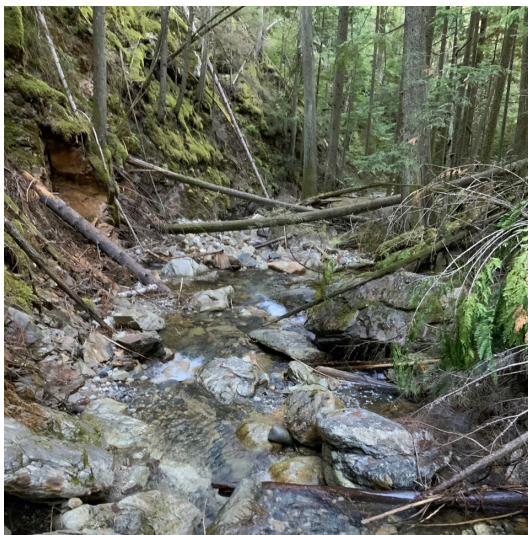
Photo 9.
Looking north (downstream) at bedrock-controlled channel of Mara Creek approximately 150 m upstream of fan-delta apex.

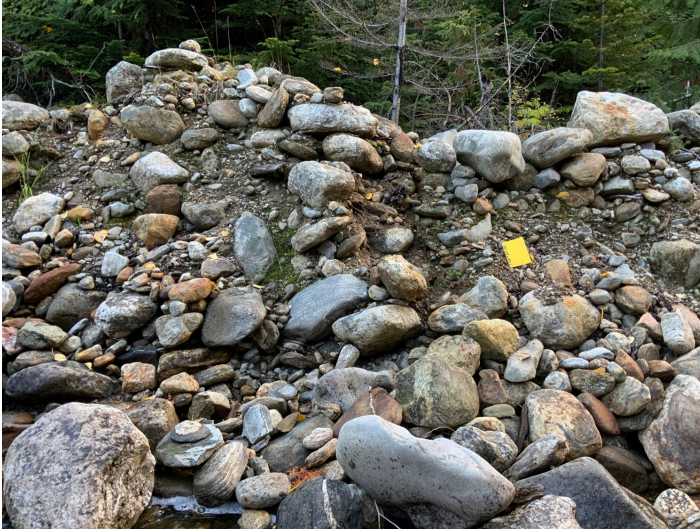
Photo 10.

Looking north at debris flood deposits downstream of a forestry road crossing in the Hummingbird Creek watershed approximately 4 km upstream of the fan-delta apex. Note the yellow notebook (approximate 15 cm tall) for scale compared to the size of the gravels and boulders in the deposit.

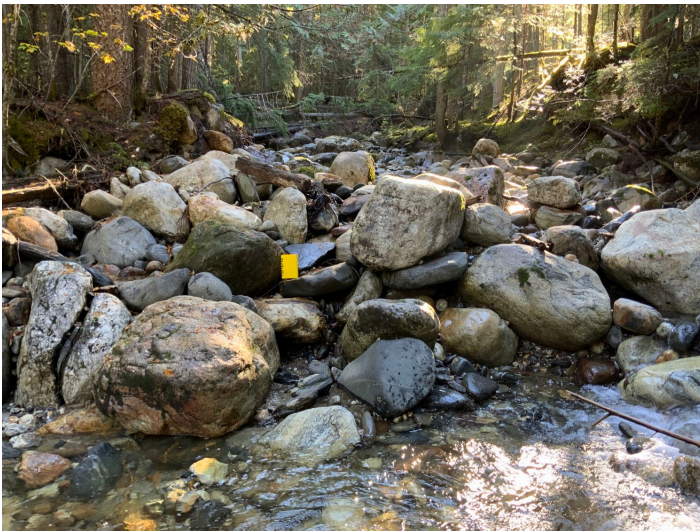
Photo 11.

Looking south (upstream) at approximately 10-year-old debris flood deposits in Mara Creek approximately 1.6 km upstream of the fan-delta apex. Note the yellow notebook (approximate 15 cm tall) for scale compared to the size of the boulders in the channel.

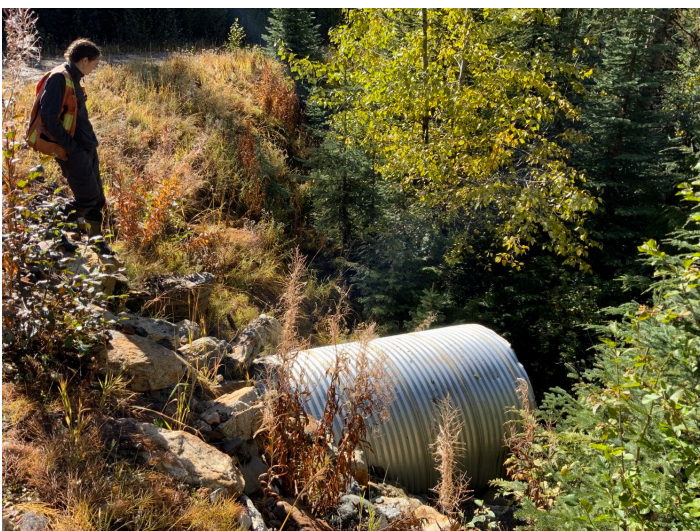
Photo 12.

Looking south at an approximately 1.8 m diameter culvert under a forestry road in the Mara Creek watershed.

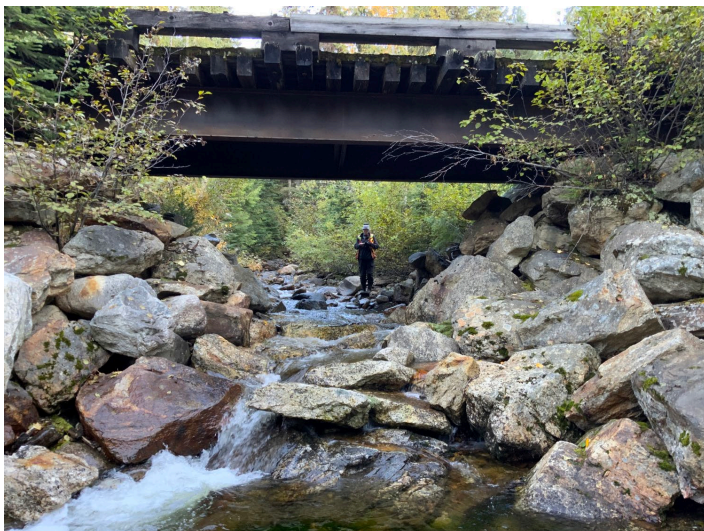
Photo 13.
Looking northeast at an approximately 11 m long forestry road bridge approximately 3.9 m above Hummingbird Creek. The bridge is approximately 4 km upstream of the fan-delta apex.

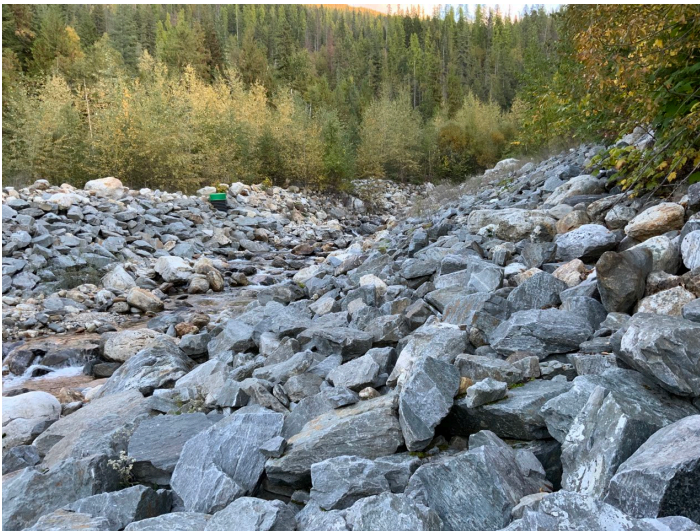
Photo 15.
Looking east (upstream) at the Hummingbird Creek channel between the fan-delta apex and Highway 97A. Note the presence of large angular rip rap along the channel banks.

For approximately 300 m from the fan-delta apex to the Highway 97A bridge, the creek flows down an excavated channel with its banks partially armoured with riprap (large angular boulders brought in to protect the bank from erosion; see Photo 15) installed in January 2013 (Golder Associates Ltd., August 23, 2013). BGC observed that the riprap upstream of the Highway 97A bridge was partially eroded and the underlying geotextile fabric was partially exposed (Photo 19). A similar deficiency was noted near the Highway 97A bridge following the 2017 and 2018 floods (nhc, August 7, 2020) and was repaired in October 2020 (Binnie Construction Services Ltd., October 24, 2020).

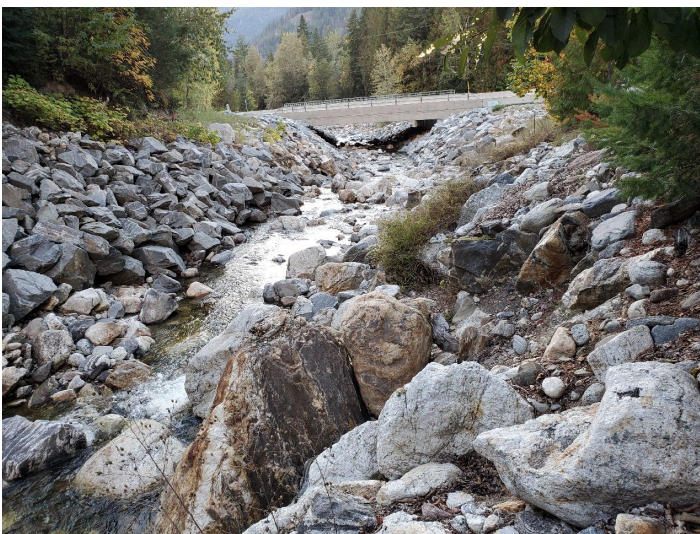
Photo 16.
Looking west (downstream) at the Highway 97A bridge over Hummingbird Creek.

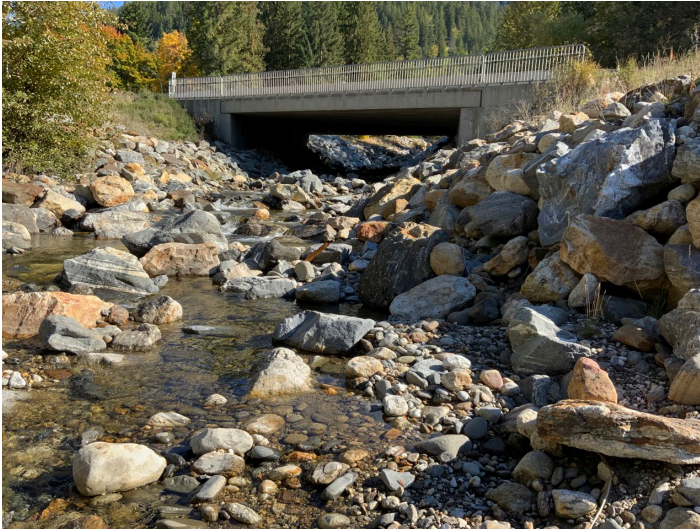
Photo 17.
Looking east (upstream) at the Highway 97A bridge over Hummingbird Creek.

At Highway 97A, the Ministry of Transportation and Infrastructure (MOTI) constructed an 18 m long and 18 m wide bridge in 2015 (Photos 16 and 17). At the base of the bridge, the channel bottom width narrows to 6.5 m. Prior to the bridge construction, Highway 97A crossed over Hummingbird Creek with a 3.8 m by 2.3 m corrugated metal pipe culvert (Photo 18). Swansea Point residents and CSRD successfully lobbied MOTI to replace the culvert with a bridge as the existing culvert would not convey the 200-year flood (Golder Associates Ltd., August 23, 2013; Labere, August 27, 2013). The design basis for the current bridge is a 200-year flood of approximately 20 m³/s (Golder, December 19, 2013).

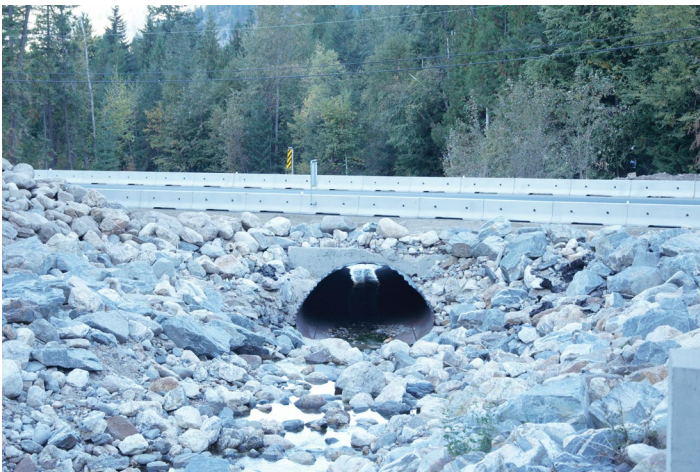
Photo 18.
Looking west (downstream) at the former culvert under Highway 97A bridge at Hummingbird Creek. Note the difference at the Highway 97A crossing compared to Photo 16.

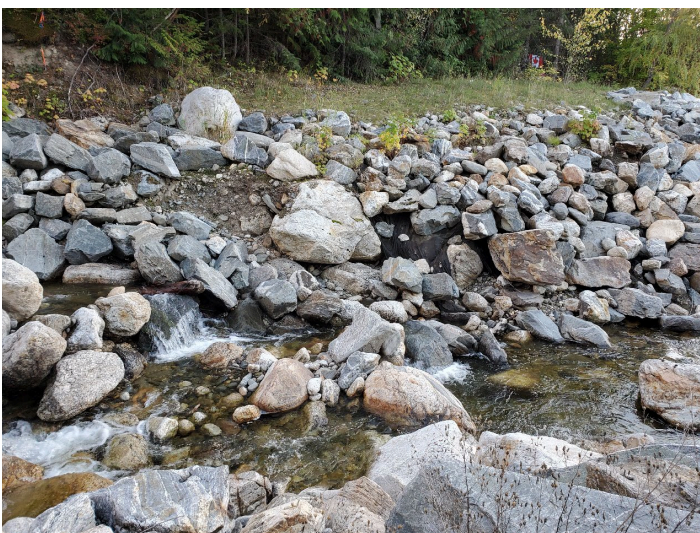
Photo 19.
Looking south (across channel) at the condition of the rip rap along the south (left) bank of Hummingbird Creek upstream of the Highway 97A bridge. Note the black fabric (geotextile) visible next to the riprap.

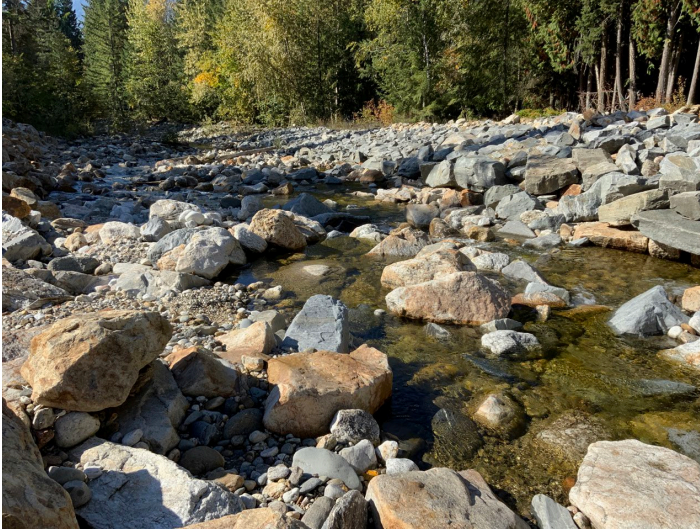
Photo 20.

Looking west (downstream) at the Hummingbird Creek channel downstream of the Highway 97A bridge. Note the presence of large angular boulders in the channel placed during mitigation in 2020 (Binnie Construction Services Ltd., October 24, 2020).

Below Highway 97A, Hummingbird Creek flows for approximately 700 m through a partially engineered channel to the outlet at Mara Lake (Photos 20 to 26). Approximately 2,900 m³ of channel bed sediment was removed in January 2013 from the lower 300 m of the channel (Golder Associates Ltd., August 23, 2013). Discontinuous riprap was later installed in the lower 400 m of the channel. However, in some locations no riprap is present adjacent to buildings (e.g., Photos 22 and 26).

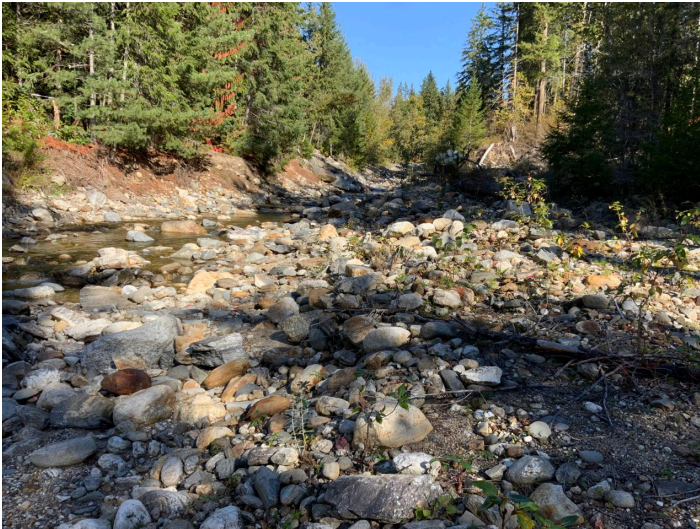
Photo 21.

Looking east (upstream) at the Hummingbird Creek channel approximately 300 m downstream of the Highway 97A bridge. Note the lack of rip rap lining the channel banks.

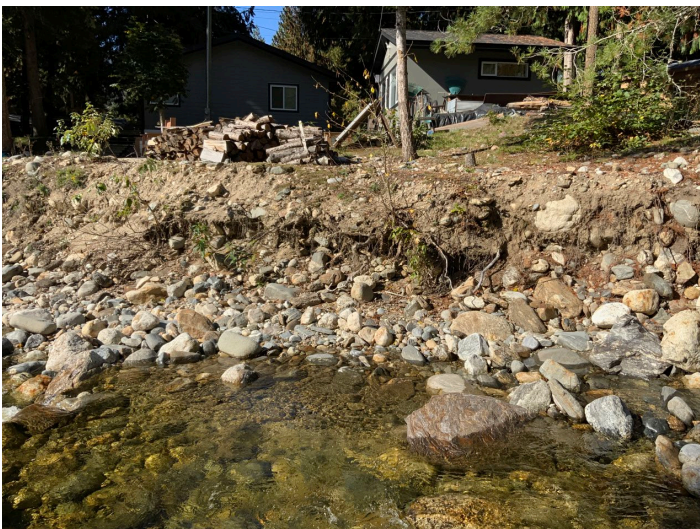
Photo 22.

Looking north at right (north) bank of Hummingbird Creek approximately 350 m downstream of the Highway 97A bridge. Note the approximately 0.75 m freeboard between the channel and the top of the bank and the buildings behind the bank.

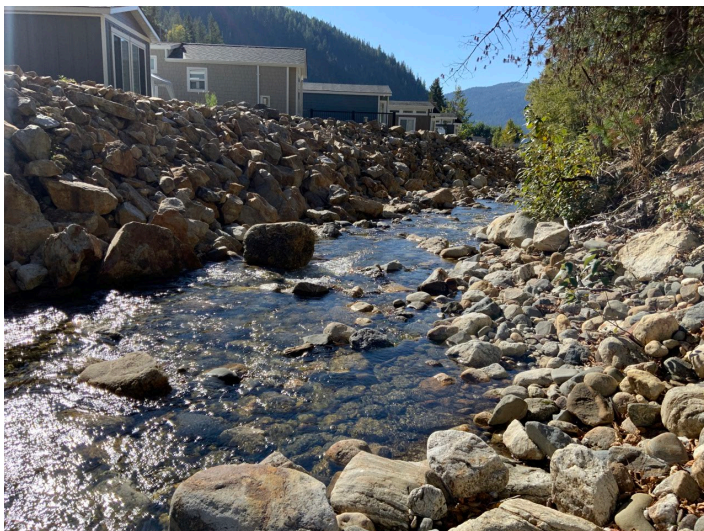
Photo 23.

Looking west (downstream) at the Hummingbird Creek channel approximately 400 m downstream of the Highway 97A bridge. Note the approximately 2.0 m freeboard between the channel and the top of the south (left) bank and the buildings behind the bank. The south (left) bank is armoured by rip rap.

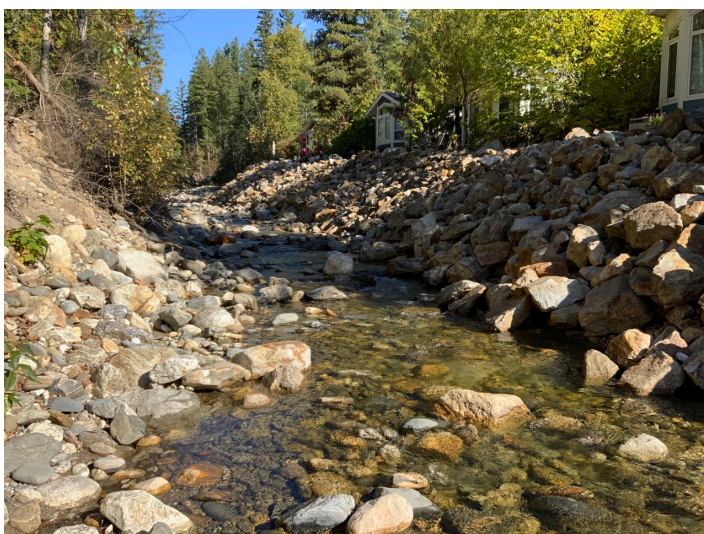
Photo 24.

Looking east (upstream) at the Hummingbird Creek channel approximately 400 m downstream of the Highway 97A bridge. Note the approximately 1.75 m freeboard between the channel and the top of the south (left) bank and the buildings behind the bank. The south (left) bank is armoured by rip rap.

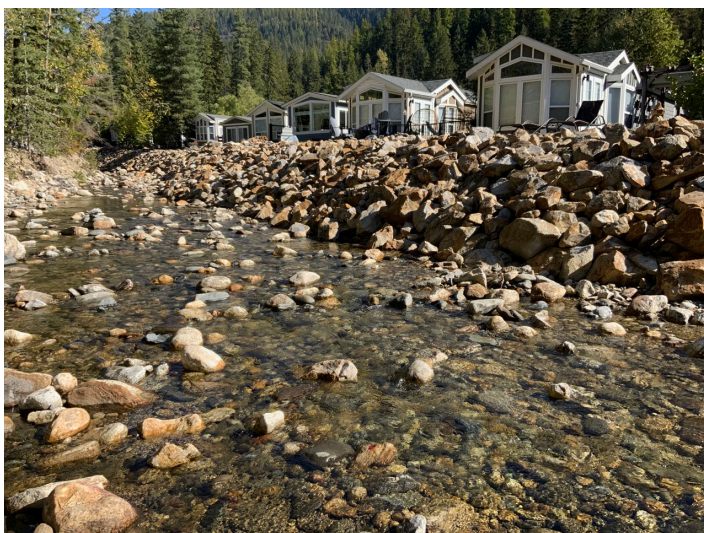
Photo 25.

Looking east (upstream) at the Hummingbird Creek channel approximately 450 m downstream of the Highway 97A bridge. Note the approximately 1.6 m freeboard between the channel and the top of the south (left) bank and the buildings behind the bank. The south (left) bank is armoured by rip rap.

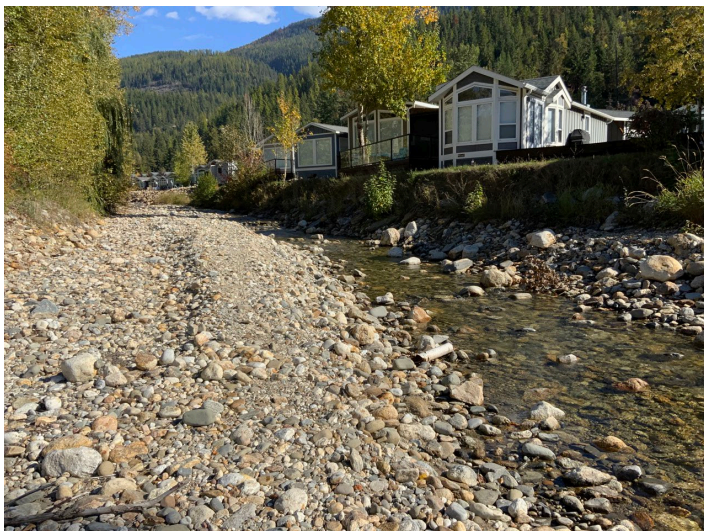
Photo 26.

Looking east (upstream) at the Hummingbird Creek channel approximately 650 m downstream of the Highway 97A bridge and near the outlet at Mara Lake. Note the approximately 1.6 m freeboard between the channel and the top of the south (left) bank and the buildings behind the bank. The south (left) bank is not armoured by rip rap.

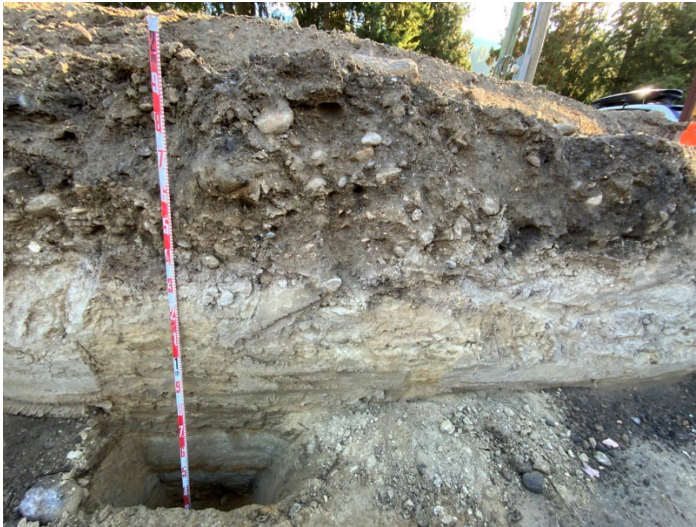
Photo 27.

Looking east at HUM-TP-02 SA-01 (see location in Drawing 06). A radiocarbon date from this prehistoric debris flow or debris flood deposit dated this sediment to approximately 580 years before present.

Event Date	Type of Event	Source of Event	Sediment volume (m ³)	Peak discharge (m ³ /s)	Damages	Notes
580 years before present	Unknown	Radiocarbon date from HUM-TP-02 SA-01 (Drawing 05)	Unknown	Unknown	Unknown	A prehistoric debris flow or debris flood reached the fan-delta margin near Mara Lake. The deposit was approximately 1.0 m below the surface (Photo 27) and indicates that prehistoric events were large enough to deposit thick sediment far away from the fan-delta apex.
150 years before present	Unknown	Radiocarbon date from HUM-TP-02 SA-01 (Drawing 05)	Unknown	Unknown	Unknown	A prehistoric debris flow or debris flood reached the fan-delta margin near Mara Lake. The deposit was approximately 0.7 m below the surface (Photo 28) and indicates that prehistoric events were large enough to deposit thick (approximately 0.3 m) sediment far away from the fan-delta apex. Regional high water and flood event occurred around this time in 1894.

Two radiocarbon samples were obtained from an existing foundation excavation at 8905 Swanshore Road (Photo 27 and 28 in Photo Appendix). Table C-5 summarizes the results of the lab testing and information about the sample location in relation to observed deposits. Given that BGC only collected two samples, the inferences that can be made are minimal: that is, debris flows or debris floods have occurred in the past and they have reached the edge of the fan-delta boundary in a single event.

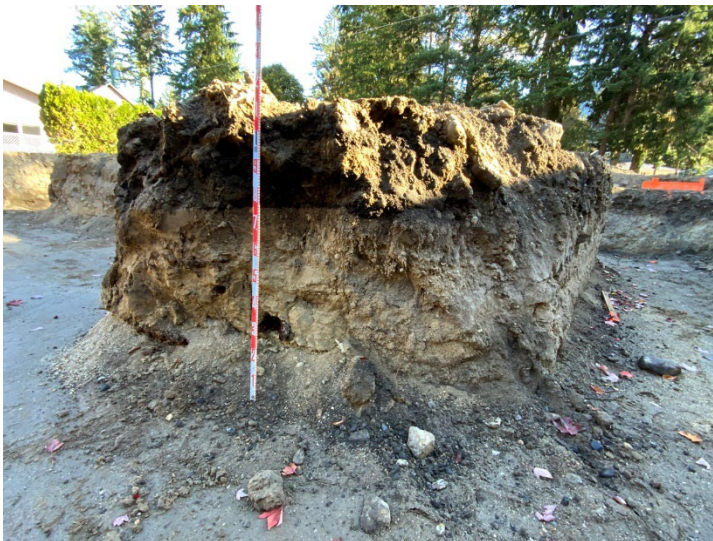
Photo 28.

Looking west at HUM-TP-02 SA-01 (see location in Drawing 06). A radiocarbon date from this prehistoric debris flow or debris flood deposit dated this sediment to approximately 150 years before present.

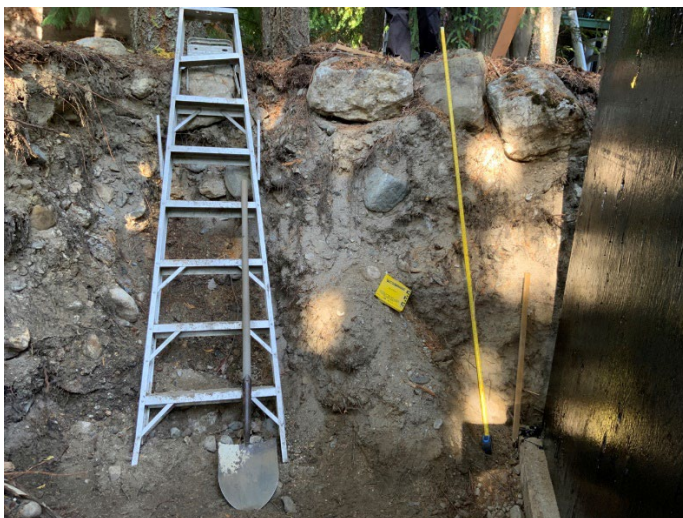
Photo 29.

Looking north at homeowner excavation on the upper fan-delta comprised of approximately 1.2 m of 1997 debris flow deposits. Note the size of the boulders near the top of the excavation compared to the 15 cm yellow notebook.

Event Date	Type of Event	Source of Event	Sediment volume (m ³)	Peak discharge (m ³ /s)	Damages	Notes
July 11, 1997	Debris flow	Government of BC (October 1997); EBA and KWL (March 11, 1998); Jakob et al. (2000)	92,000	1,000	Upstream of Highway 97A, direct impact of debris flow against five homes (Photos 29 to 31), and water wells were buried or destroyed. Highway 97A culvert crossing was overtopped, and the road base was damaged from erosion. Downstream of Highway 97A, overland flow and avulsions caused road damage (Photos 32 and 33) and damaged septic fields. One person died of a heart attack during recovery efforts.	The debris flow originated on a steep (greater than 35°) slope below the Ashton-Mara East Forest Service Road (locally known as "Skyline Road") approximately 2 km upstream of the fan-delta apex on Hummingbird Creek (Forest Practices Board, August, 2011). Jakob et al. (2000) note that 1997 was abnormally wet year, with higher-than-normal snowpack in the months leading up to the debris flow. On the day of the event, peak rainfall intensity reached 6 mm/hr with 85 mm of rainfall recorded in the adjacent watershed of Sicamous Creek on the day of the event (Jakob et al., 2000). Salmon Arm received 18 mm of rain on this day and 22 mm of rain the day preceding the debris flow.

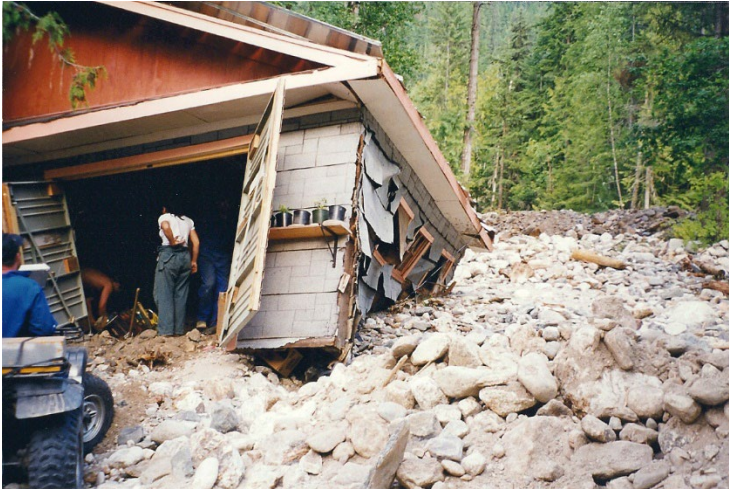
Photo 30.
Looking at damages to an unknown building on the upper fan-delta due to the Hummingbird Creek debris flow on July 11, 1997.

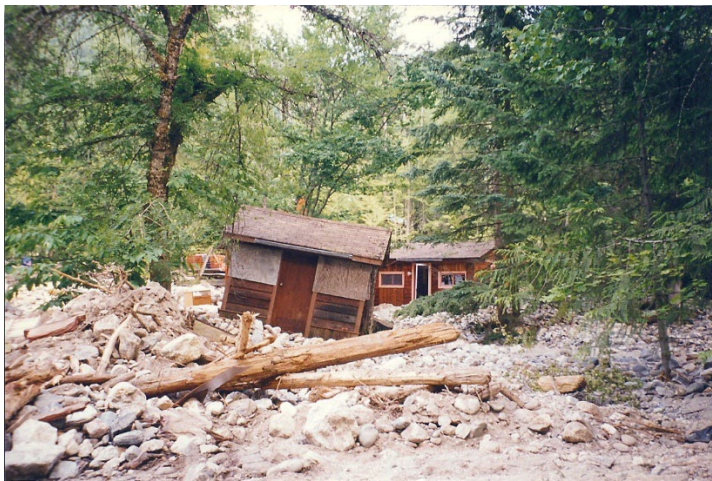
Photo 31.
Looking at damages to unknown buildings on the upper fan-delta due to the Hummingbird Creek debris flow on July 11, 1997.
