FBC DETAILED FLOOD MAPPING STUDY

Hummingbird Creek

FINAL
January 31, 2023

Prepared by BGC Engineering Inc. for:
Fraser Basin Council

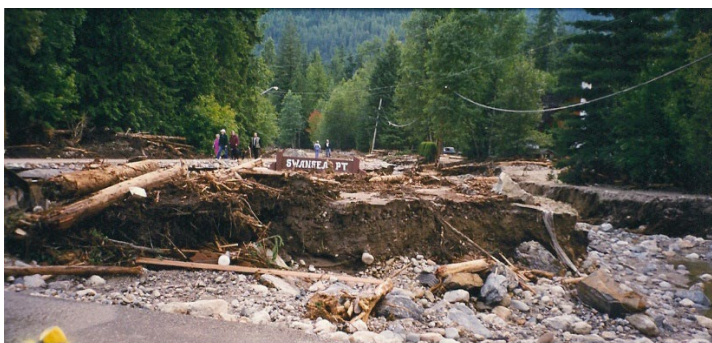
Photo 32.
Looking south from Highway 97A at the damages from the Hummingbird Creek debris flow on July 11, 1997.

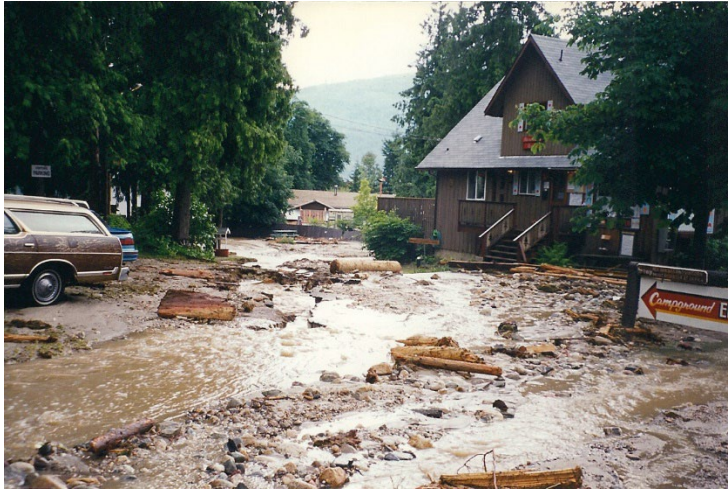
Photo 33.
Looking west at 718 Swansea Point Road on the lower fan-delta and the damages from the Hummingbird Creek debris flow on July 11, 1997.

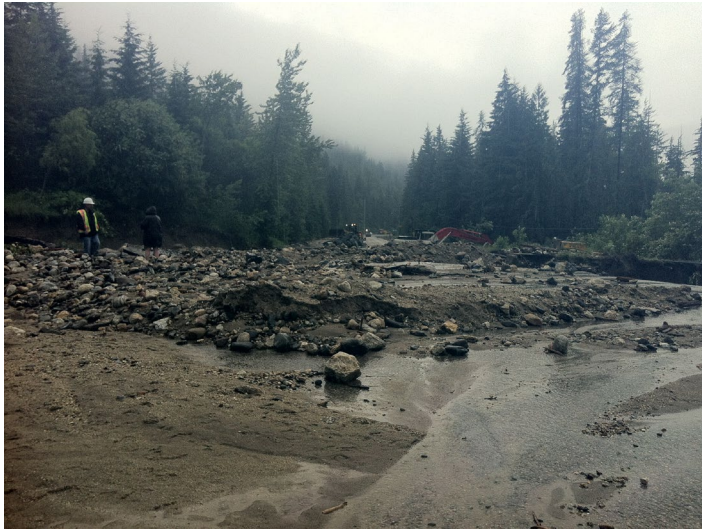
Photo 34.
Looking south at the Highway 97A Hummingbird Creek culvert crossing following the 2012 debris flood.

Following the 1997 event, a debris flood occurred in June 2012 that once again blocked the Highway 97A culvert, leading to damages to the highway and surrounding roads. This event was smaller than the 1997 event and no houses were structurally damaged, although highway and road damage occurred, and houses incurred flooding and minor sediment incursion. Following the 2012 debris flood, Swansea Point residents and Columbia Shuswap Regional District (CSR) successfully lobbied the provincial government to replace the Highway 97A culvert with a bridge, which was completed in 2015.

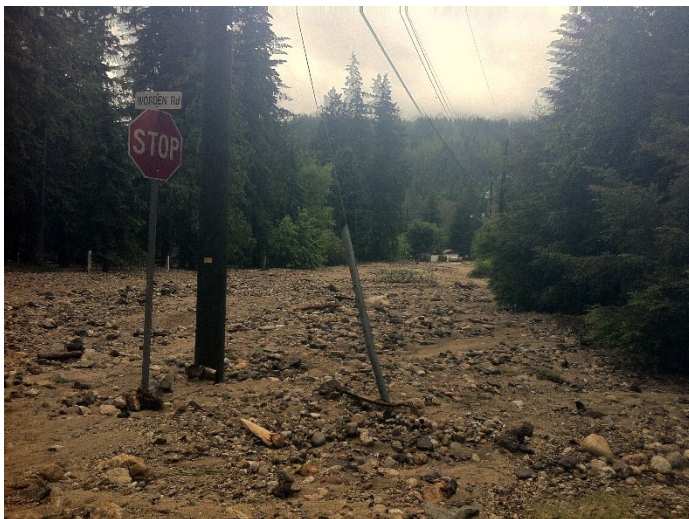
Photo 35.
Looking west at Swansea Point Road and the Hummingbird Creek avulsion channel following the 2012 debris flood.

June 23, 2012	Debris flood and lake flooding	Shuswap Lake Watch (n.d.); Golder (August 23, 2013)	22,000	N/A	Highway 97A culvert crossing was overtopped, and the road base was damaged from erosion. Downstream of Highway 97A, overland flow and avulsions caused road damage (Photos 34 to 38)	The debris flood coincided with the second highest lake level recorded on Mara Lake. BGC observed evidence of this debris flood in Mara Creek (location shown in Drawing 05). Salmon Arm received 25 mm of rain. A major and destructive debris flood occurred on nearby Sicamous Creek.
2017	Flood	Northwest Hydraulic Consultants (NHC, August 7, 2020)	Unknown	Unknown	High flows damaged riprap protection upstream of Highway 97A bridge.	NHC (August 7, 2020) attributed the flooding to high snowpack, warmer than normal temperatures, and heavy precipitation. High intensity (more than 20 mm/day) rain fell in Salmon Arm on May 4 and May 11, 2012.

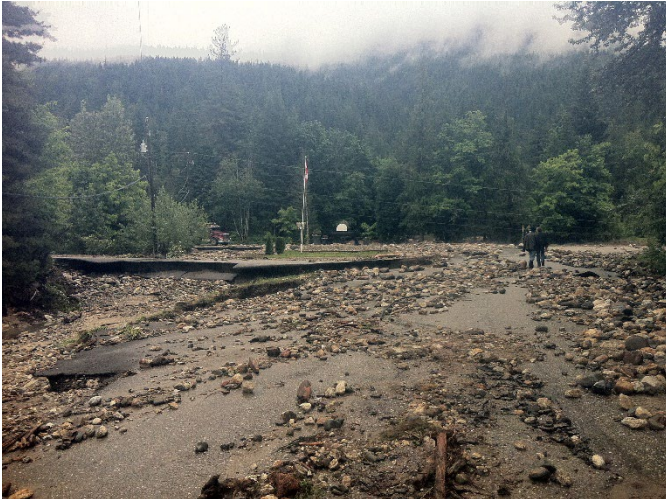
Photo 36.
Looking east at Swansea Point Road, Highway 97A, and the Hummingbird Creek avulsion channel following the 2012 debris flood.

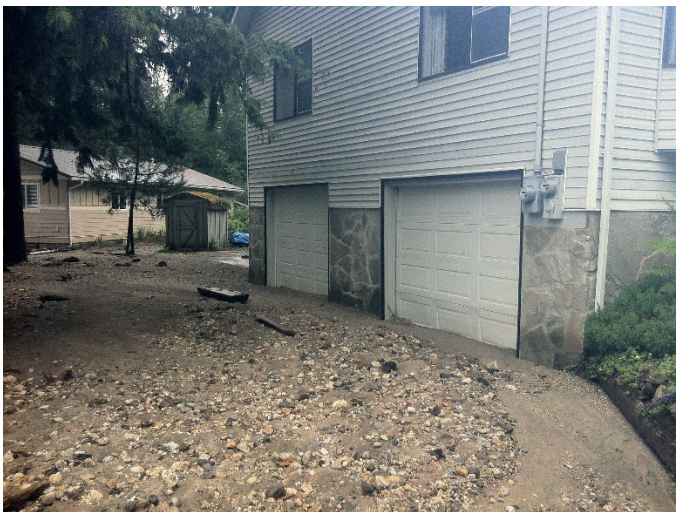
Photo 37.
Looking at debris deposition at an unknown house on the lower fan-delta following the 2012 debris flood.

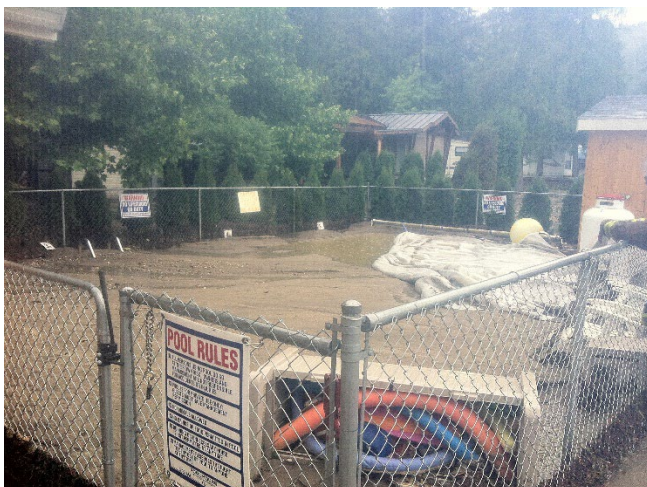
Photo 38.
Looking south at sediment deposited into pool at 718 Swansea Point Road on the lower fan-delta following the 2012 debris flood.

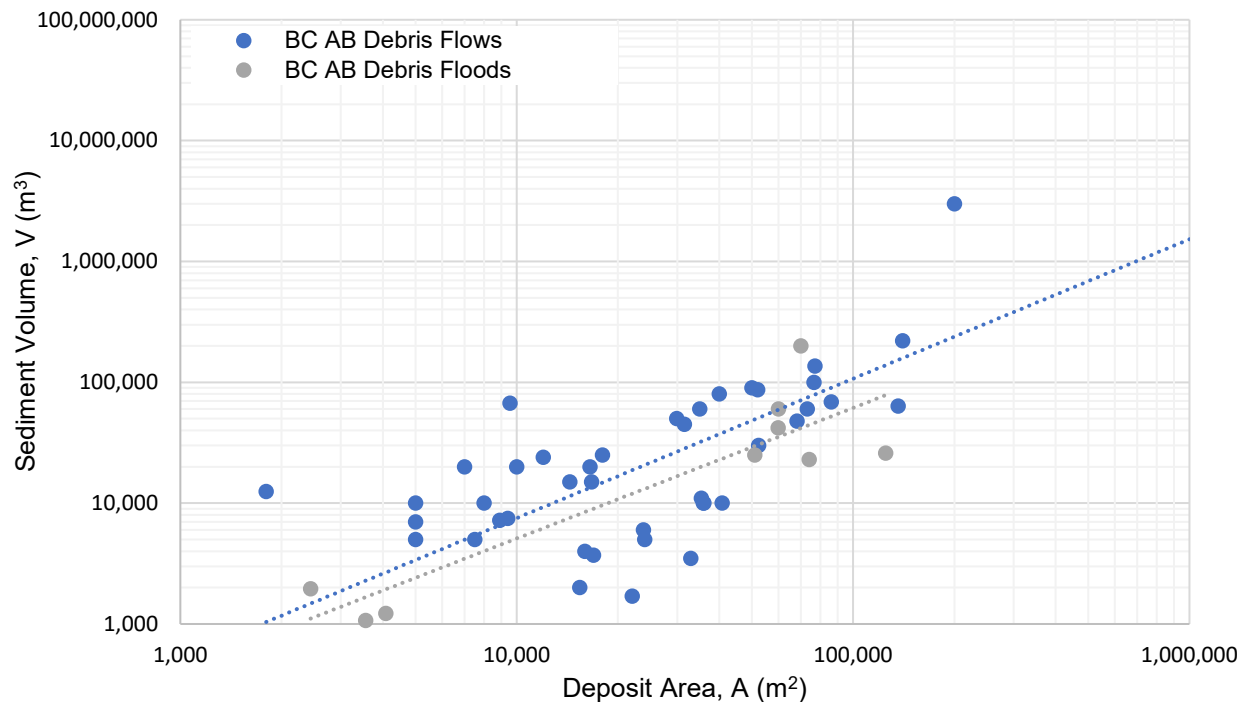
Figure C-2. Empirical area-volume relationships for debris flows and debris floods in BC and AB from documented case studies in the literature and other BGC studies.

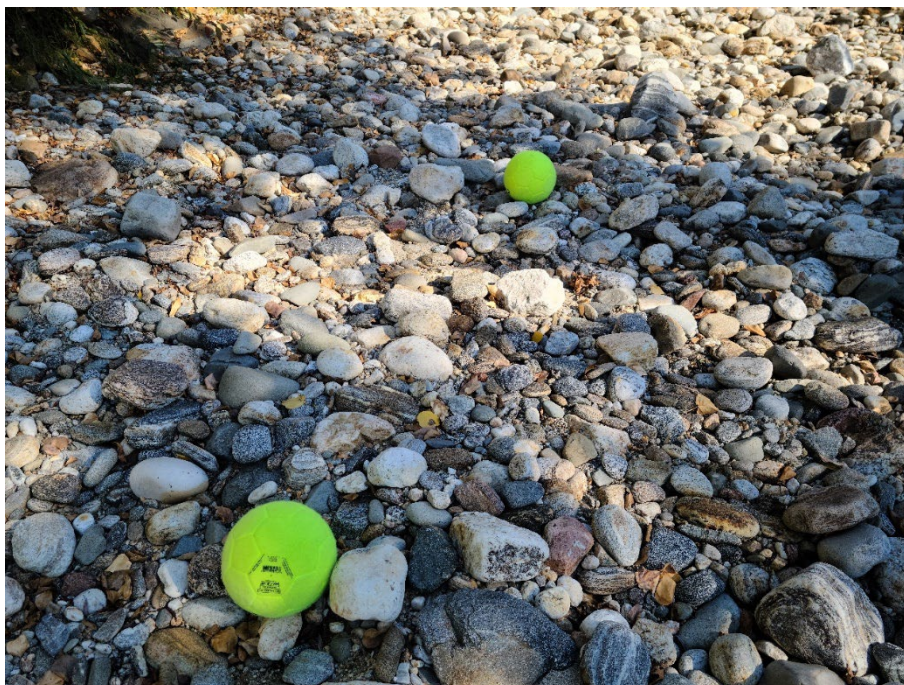
Figure C-3. Oblique photo of the channel bed material in the lower reaches of Hummingbird Creek.

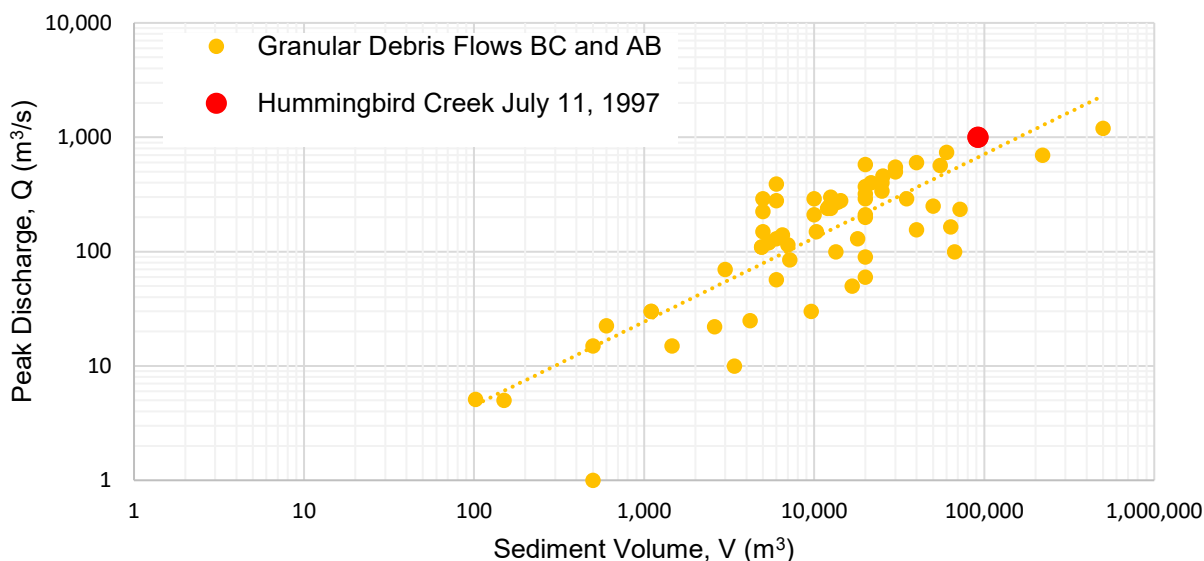
Figure C-5. Relation between peak discharge, Q and sediment volumes, V for reported debris flow events in Southwestern BC and AB.

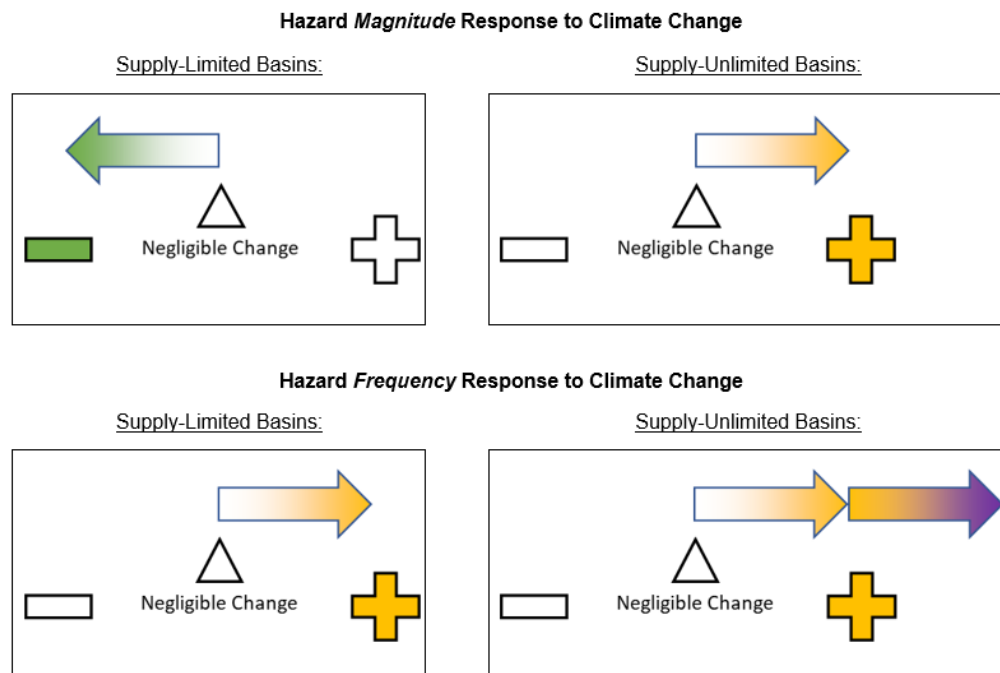
Figure C-6. Steep creek hazard sensitivity to climate change – supply-limited and supply unlimited basins.

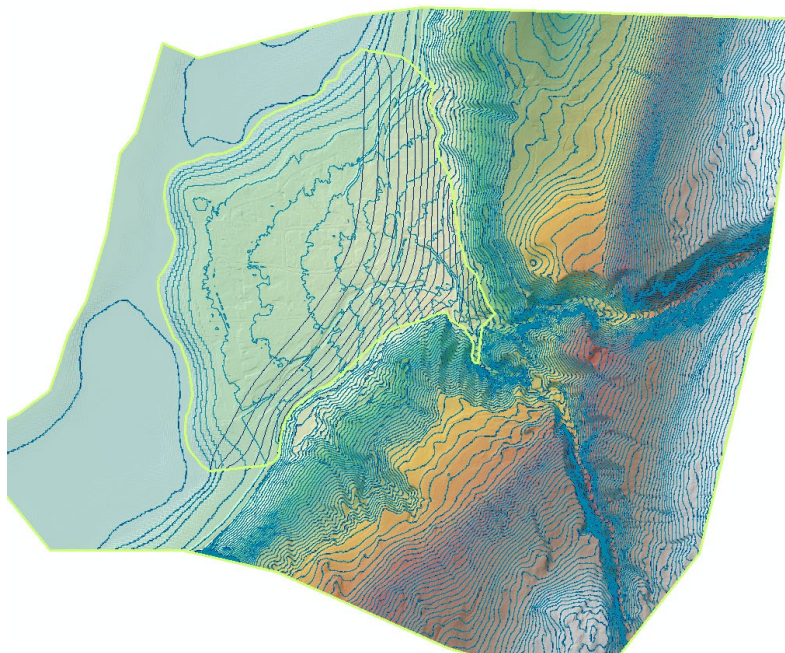
Figure C-7. Best estimate of the “no fan” topography reconstruction using the SLBL method (black 5 m contours) against the present-day topography (blue 5 m contours).

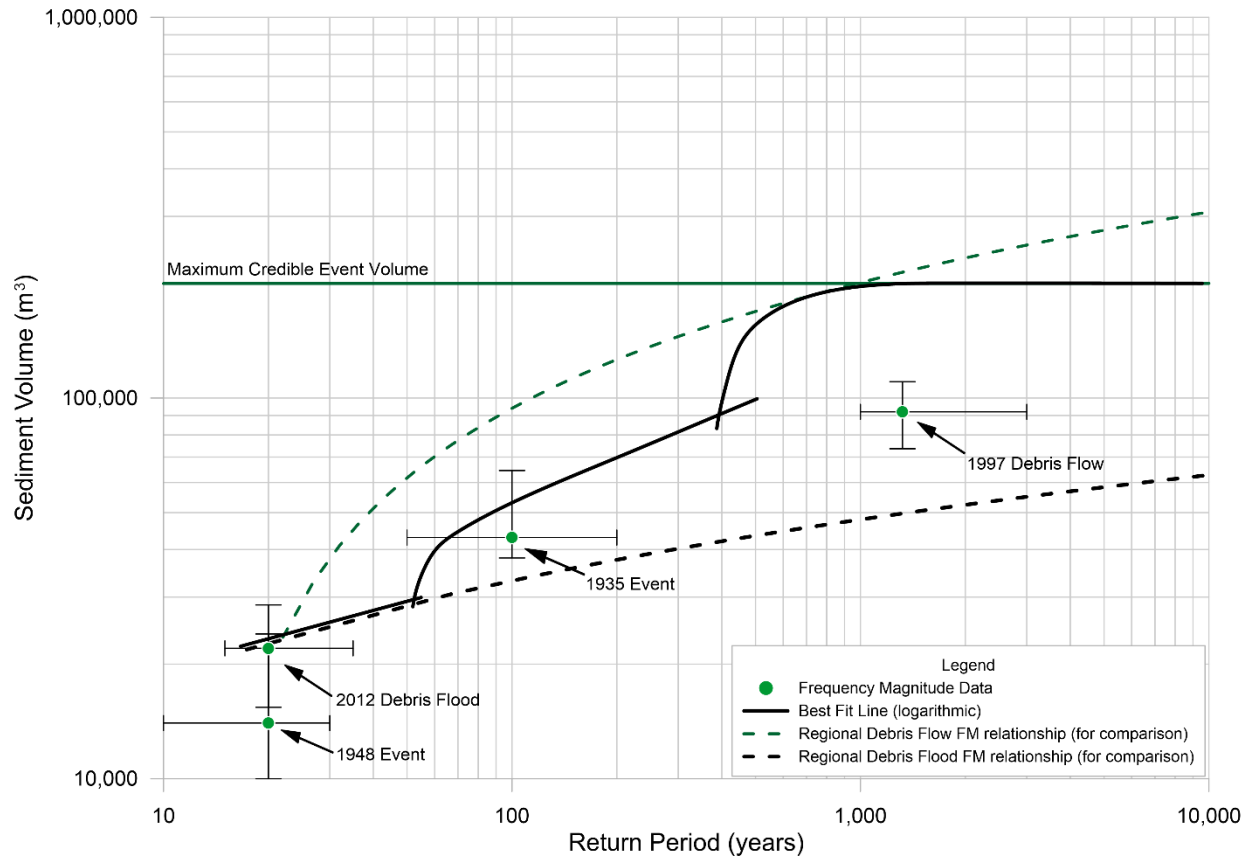
Figure C-8. The frequency-volume curve methods considered reasonable for Hummingbird Creek. Error bars are based on judgement.

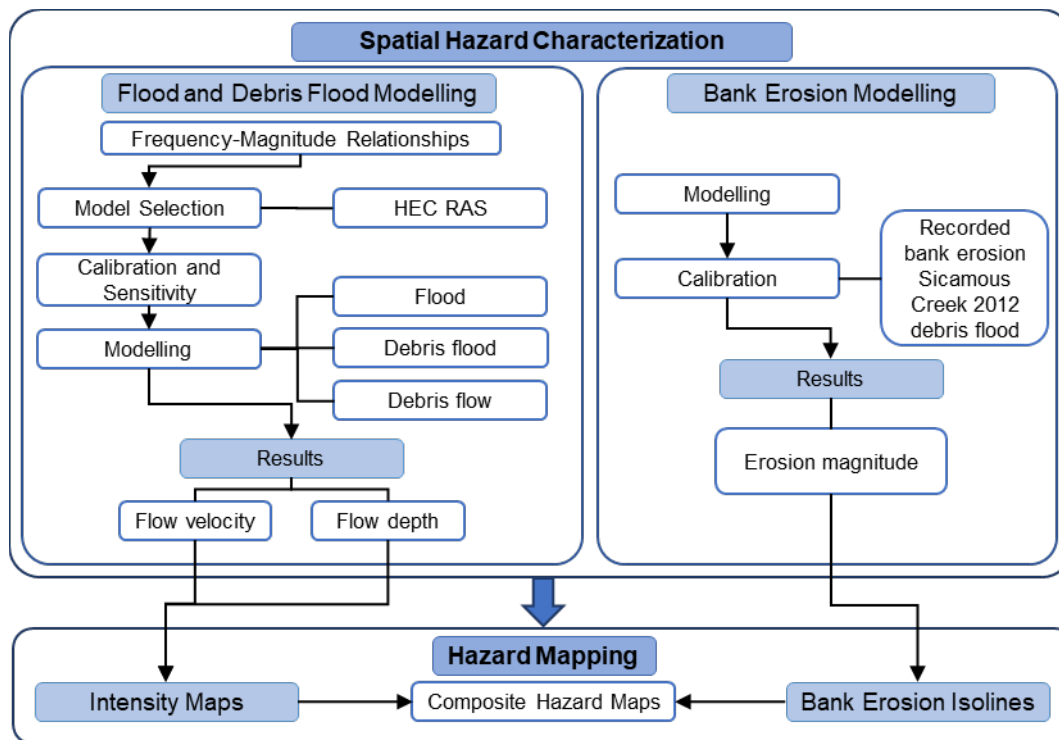
Figure D-1. Workflow applied to characterize the spatial hazard from debris floods and debris flows at Hummingbird Creek resulting in a composite hazard map.

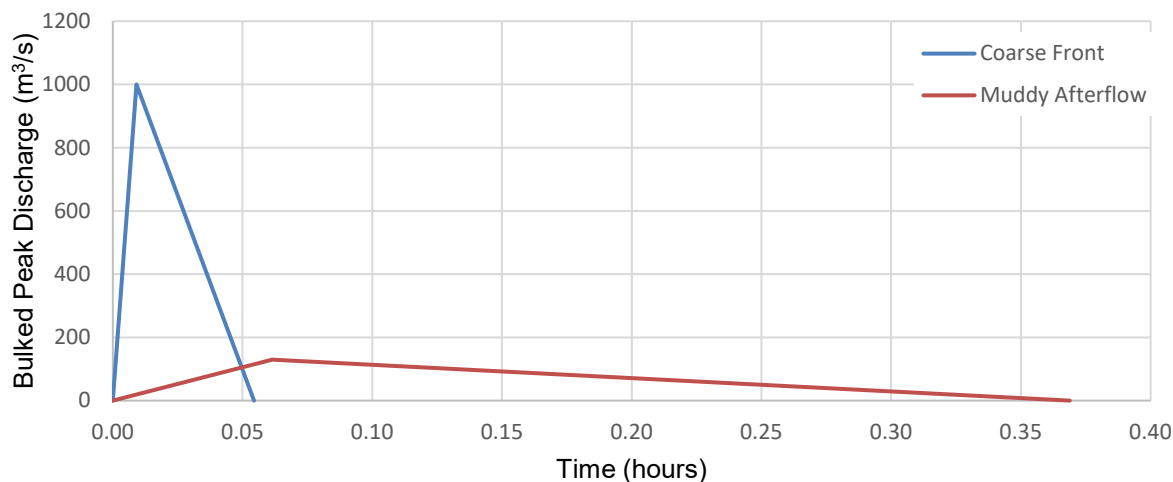
Figure D-3. 1997 flow hydrograph split for the initial surge and the hyperconcentrated afterflow. The initial surge is assumed to be associated with the peak discharge.

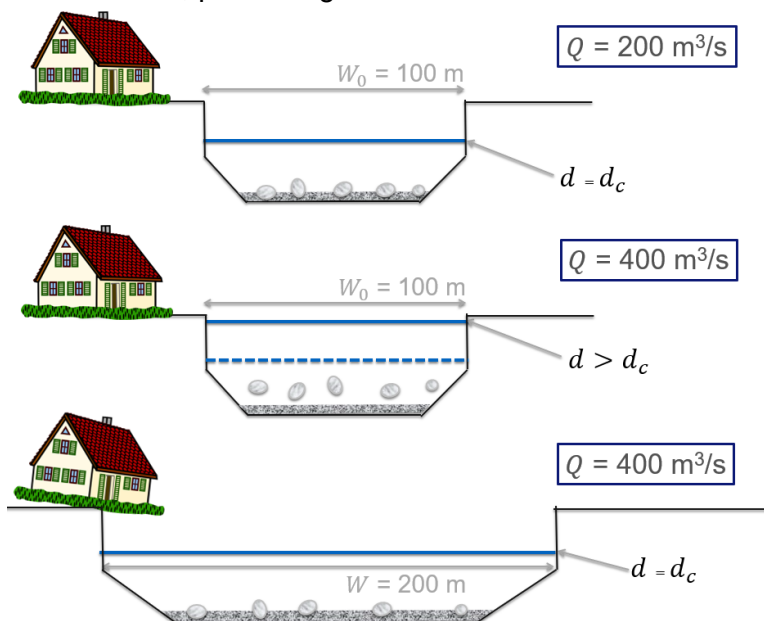
Figure D-4. Schematic showing channel widening to maintain a flow depth equal to the critical value during a flood or debris-flood event.

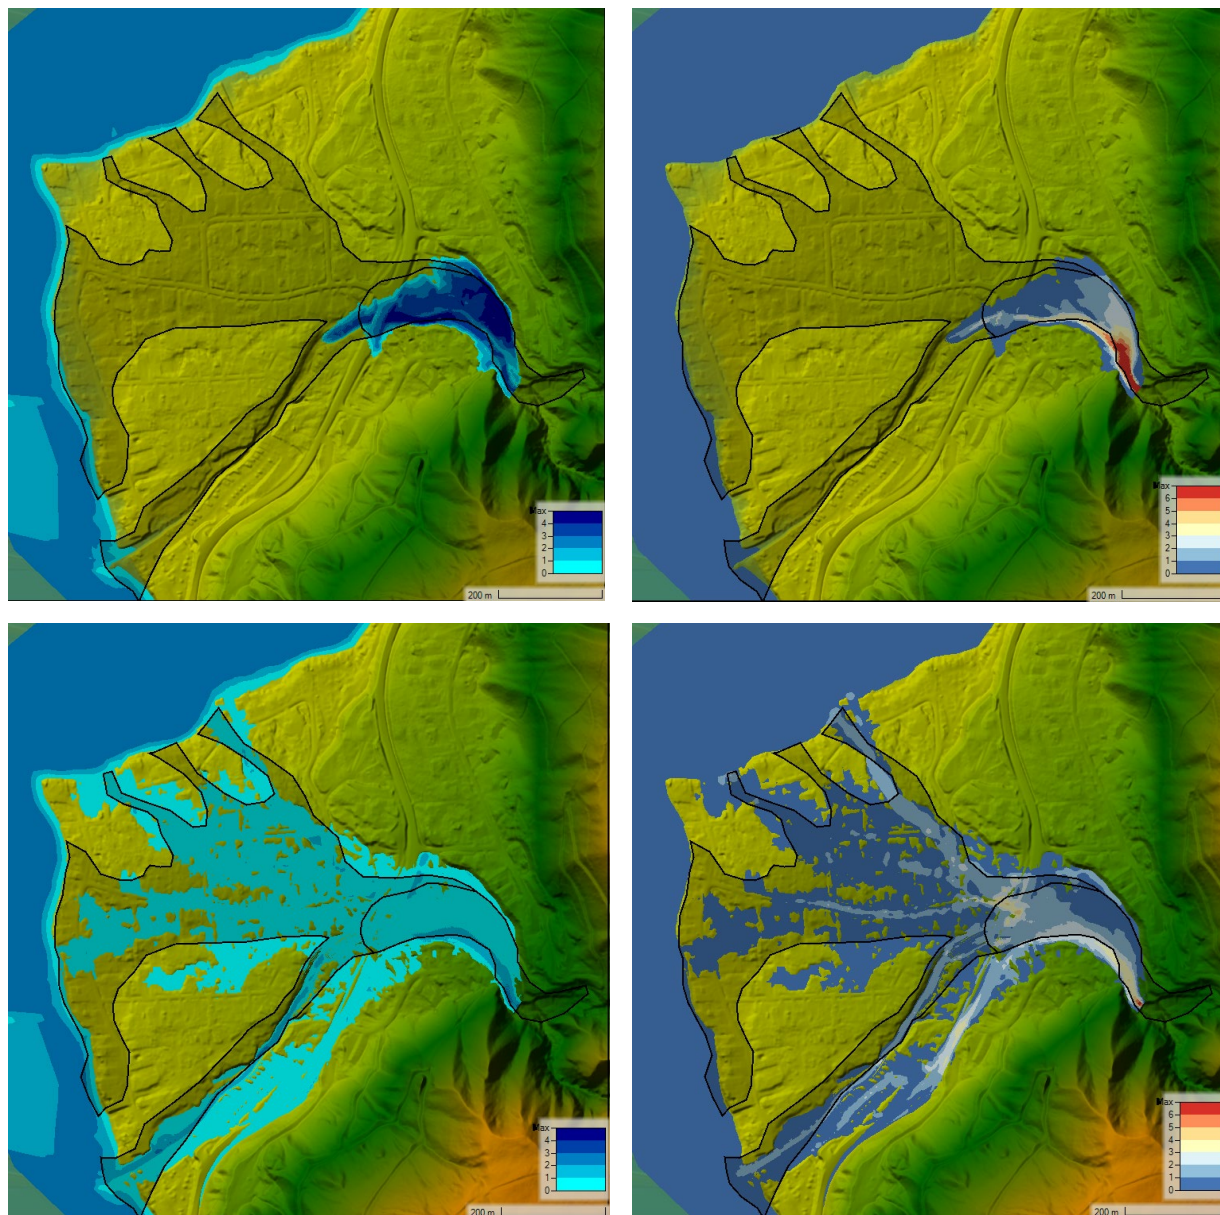
Figure D-5. Hummingbird Creek model calibration results for the debris flow on July 11, 1997 for the viscous plug (top) and low viscosity afterflow (bottom). Simulated deposit depths are on the left and maximum simulation velocities are shown on the right. Outlined in black is the 1997 debris flow deposit.
